Contract #: 04-0120F4Cty: SF/ALA Rte: 80 PM: 13.2/13.9File #: 69.28**WELDING INSPECTION REPORT****Resident Engineer:**Pursell, Gary**Address:** 333 Burma Road**City:** Oakland, CA 94607**Report No:** WIR-002538**Date Inspected:** 22-May-2008**Project Name:** SAS Superstructure**OSM Arrival Time:** 1400**Prime Contractor:** American Bridge/Fluor Enterprises, a JV**OSM Departure Time:** 2300**Contractor:** Zhenhua Port Machinery Company, Ltd (ZPMC), Changxing Island **Location:** Shanghai, China

Bridge No: 34-0006**Component:** OBG side and bottom panels and tower skin p**Summary of Items Observed:**

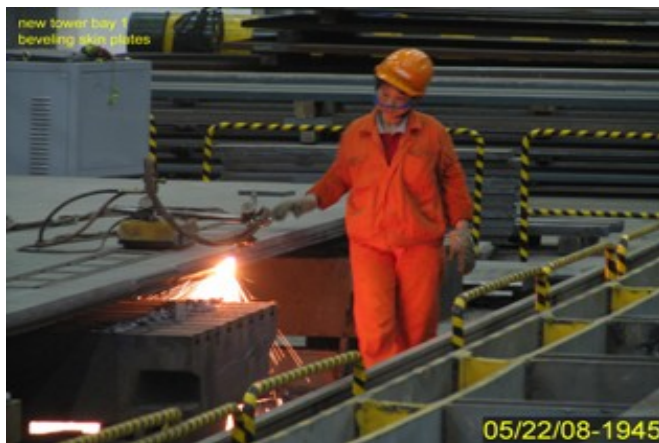
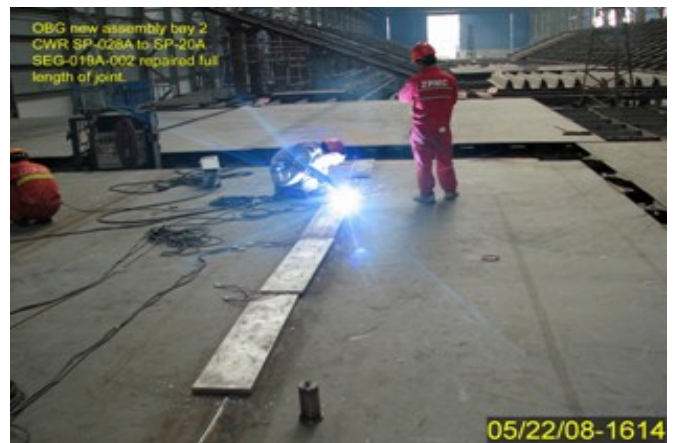
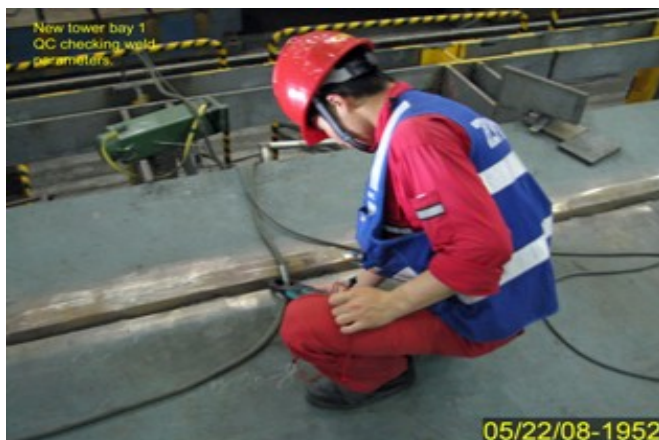
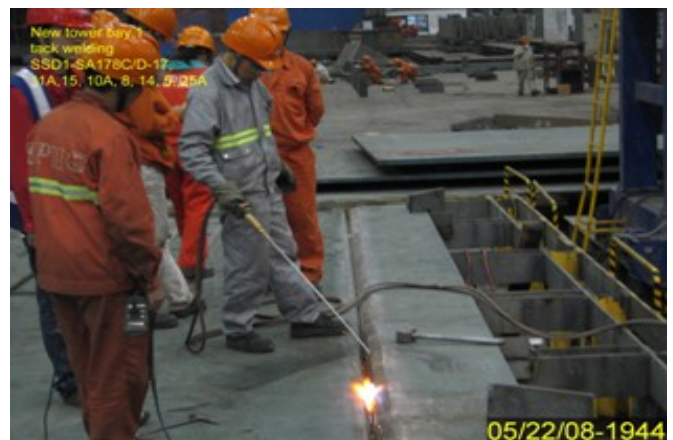
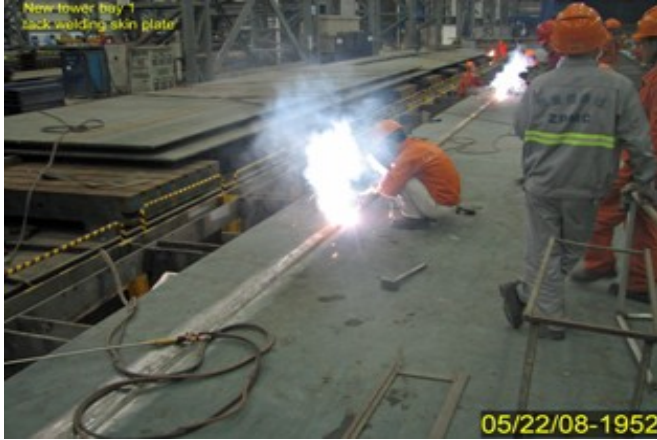
QA observed ZPMC qualified welding personnel performing a Critical Weld Repair (CWR) on SP-028A to SP-020A joint# SEG-019A-002 following the guide lines of approved CWR procedure# B-CWR-096. Apparently this weld was Ultrasonically Tested (UT) by ZPMC Quality Control (QC) UT technicians and found to be non-compliant with AWS D1.5 2002 acceptance criteria and the contract documents for the full length of the joint. QC monitored the welding process continuously throughout the evening. The welding parameters as measured with Quality Controls calibrated instruments appeared to be in conformance with the posted WPS's and were as follows:

QA noted that bottom panel BP-003 to BP-002 joint# SEG-013A-004 also appears to have been rejected by ZPMC QC UT technicians for its full length and has been excavated, cleaned and ready to be repaired by welding.

QA observed ZPMC qualified welding personnel FCAW welding cross brace connection plates on floor beam center section (FL2) Joint# SSD14-PP025-136 following the guide lines of WPS-B-T-2233-TC-U4b-F. QC

QA observed ZPMC personnel tack welding skin plate joint# SSD1-SA178C/D-17, 11A, 15, 10A, 8, 14, 5 and 25A. QA observed no other welding in this bay at the time QA was present.

QA observed ZPMC qualified welding personnel preheating tower skin plate joint# ESD1-SA294A/G-4A in preparation for SAW welding. ZPMC had not started welding on this joint before the end of QA's shift.
